## TECHNICAL MEMORANDUM

**RE: PHASE II REMEDIAL INVESTIGATION  
PROPOSED WORK PLAN FOR POLYCHLORINATED BIPHENYL  
SOURCE AREAS AND ADDITIONAL SAMPLING**

PCC Structurals Inc.  
Large Parts Campus  
Portland, Oregon

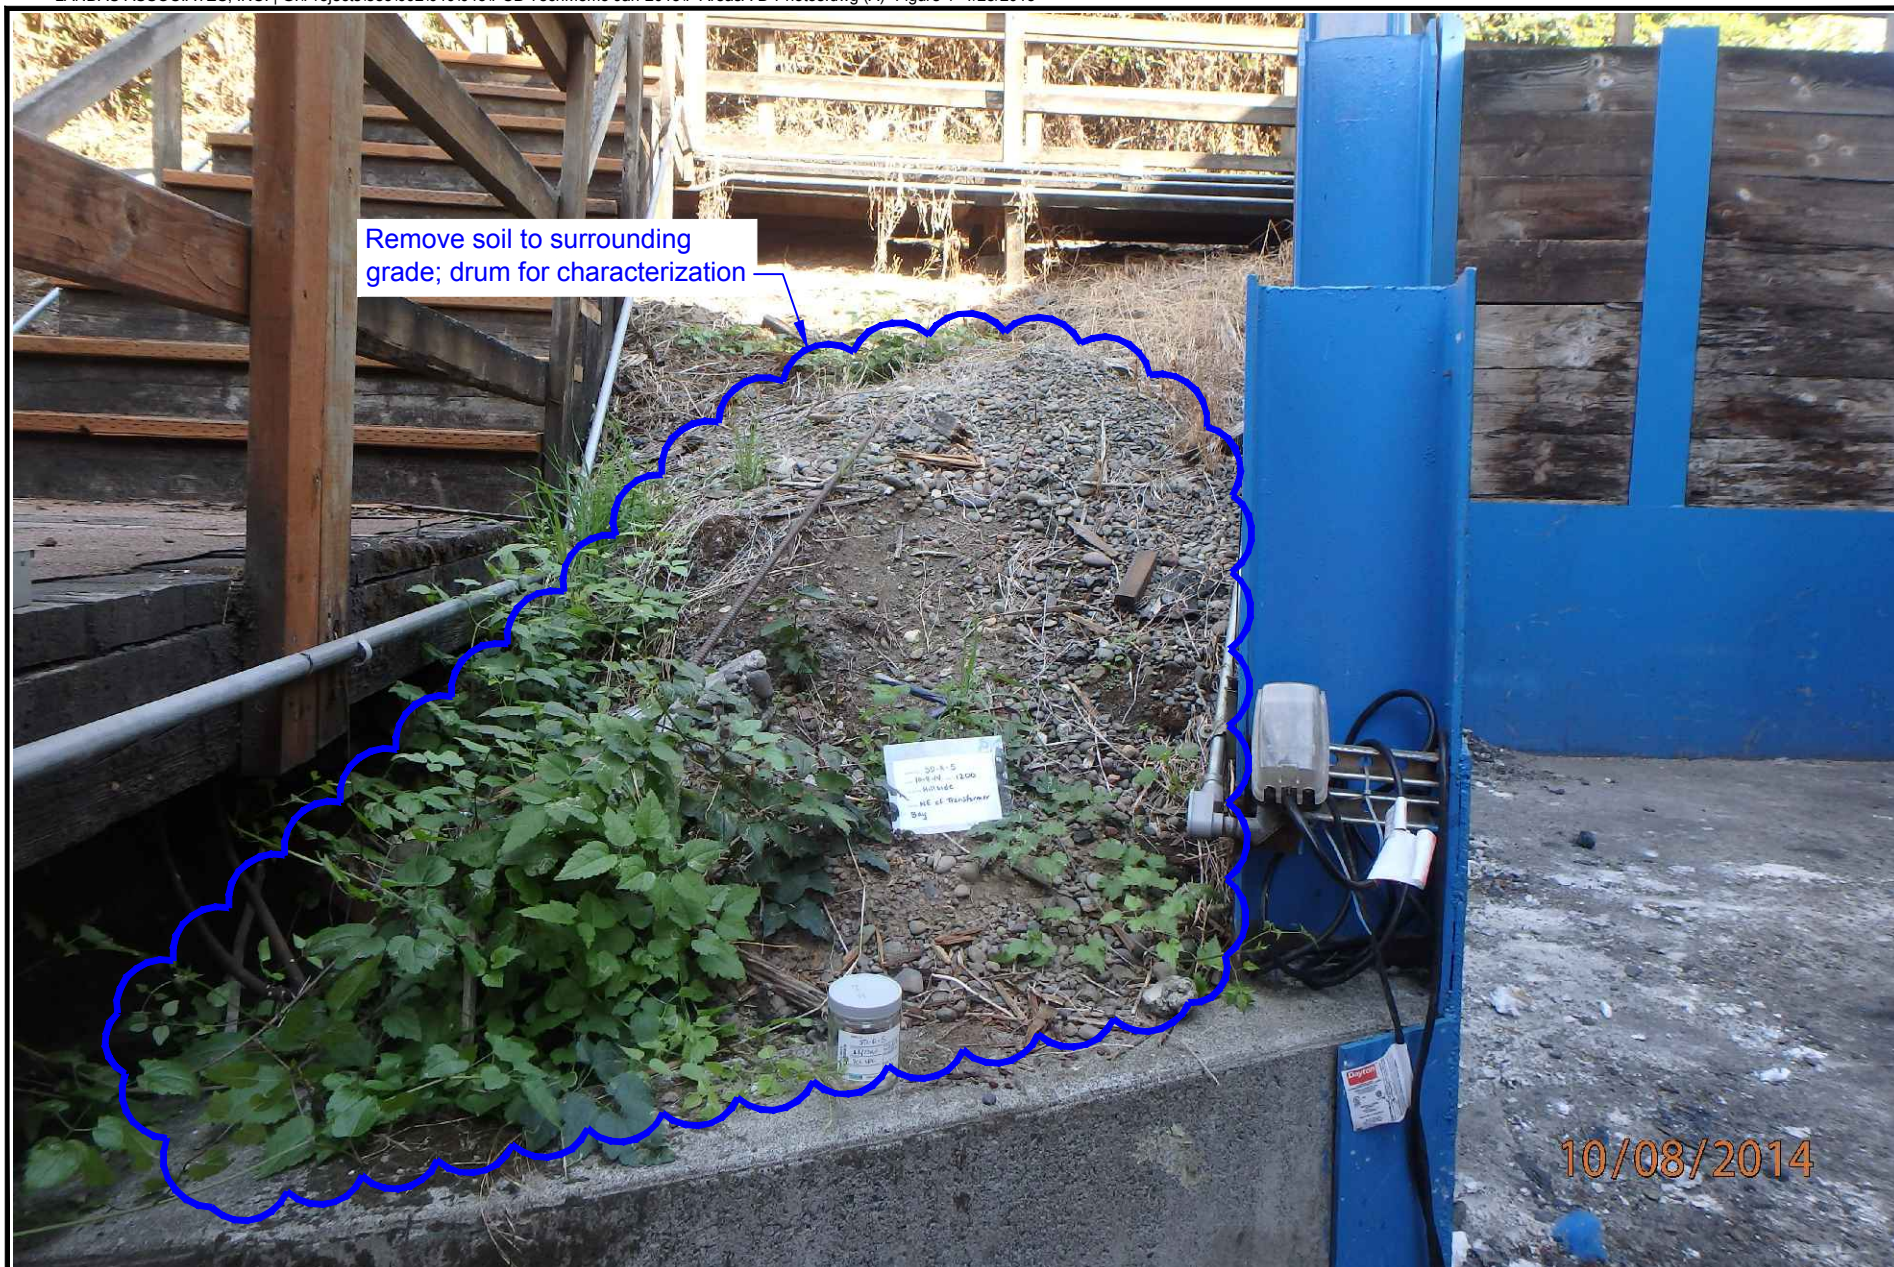
Figure 3 illustrates the proposed source control work for Area A, which includes the following:

- Sweep paved areas to remove loose soil/debris and drum for disposal characterization. After sweeping, pressure-wash the paved areas and then collect water and debris from sump in Catch Basin Z (CB-Z).
- Remove soil that is above the retaining wall to prevent future sloughing and potential transport with stormwater runoff into the sanitary sewer system and drum for disposal characterization. This soil appeared to be heaped atop existing grade. A photograph of this soil is shown on Figure 4.
- Remove loose soil and debris located on the concrete underneath the stairs and drum for disposal characterization. If possible, remove any soil above the retaining wall that would likely slough onto the concrete in this location (a westward continuation of the soil bank shown in Figure 4). A photograph of the loose soil and debris on the concrete pad beneath the staircase is shown on Figure 5.

## PCB Source Area A Proposed Work

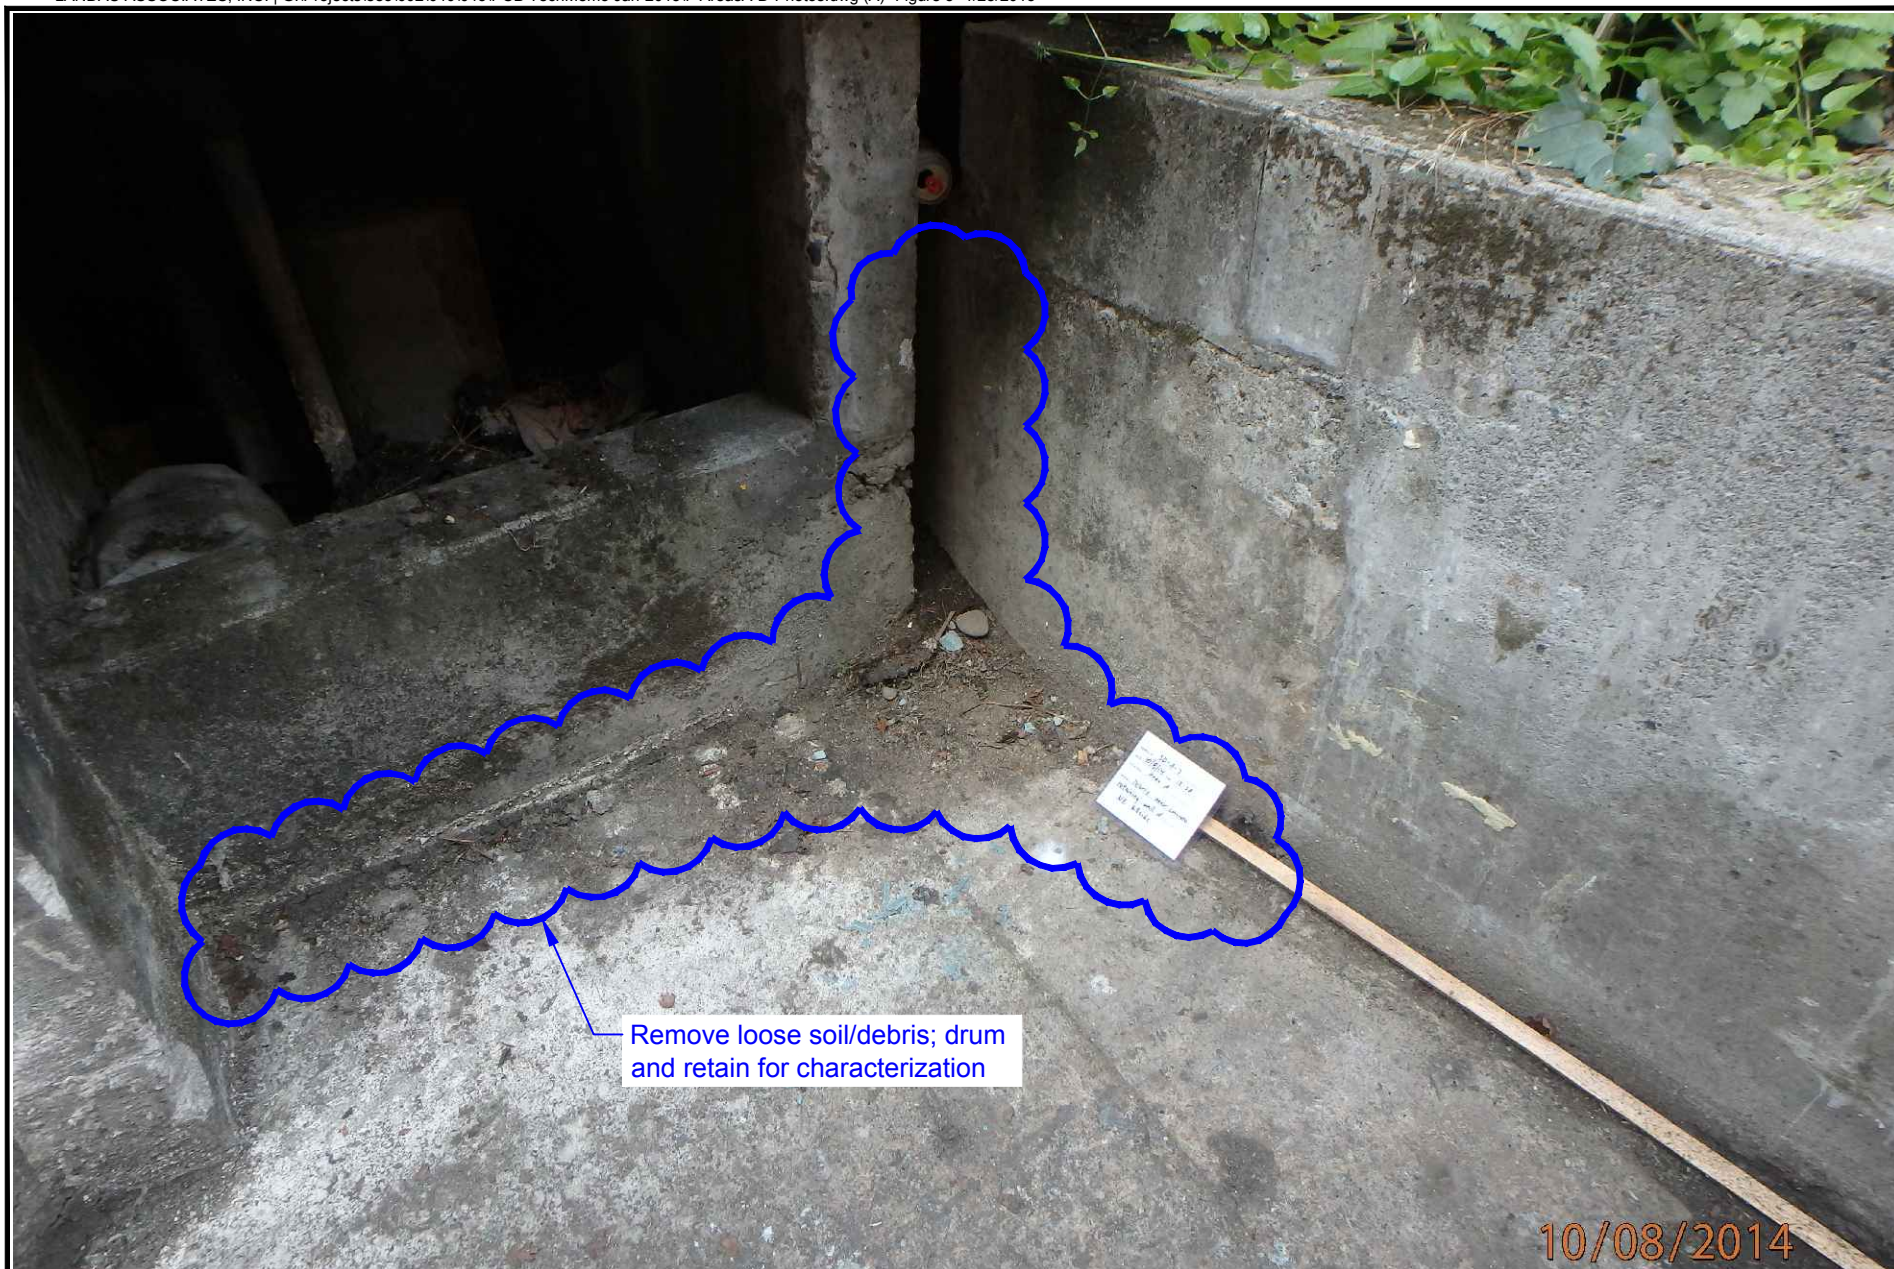
Figure  
4

Remove soil to surrounding  
grade; drum for characterization

Photo - Area A  
Soil Removal - Bank

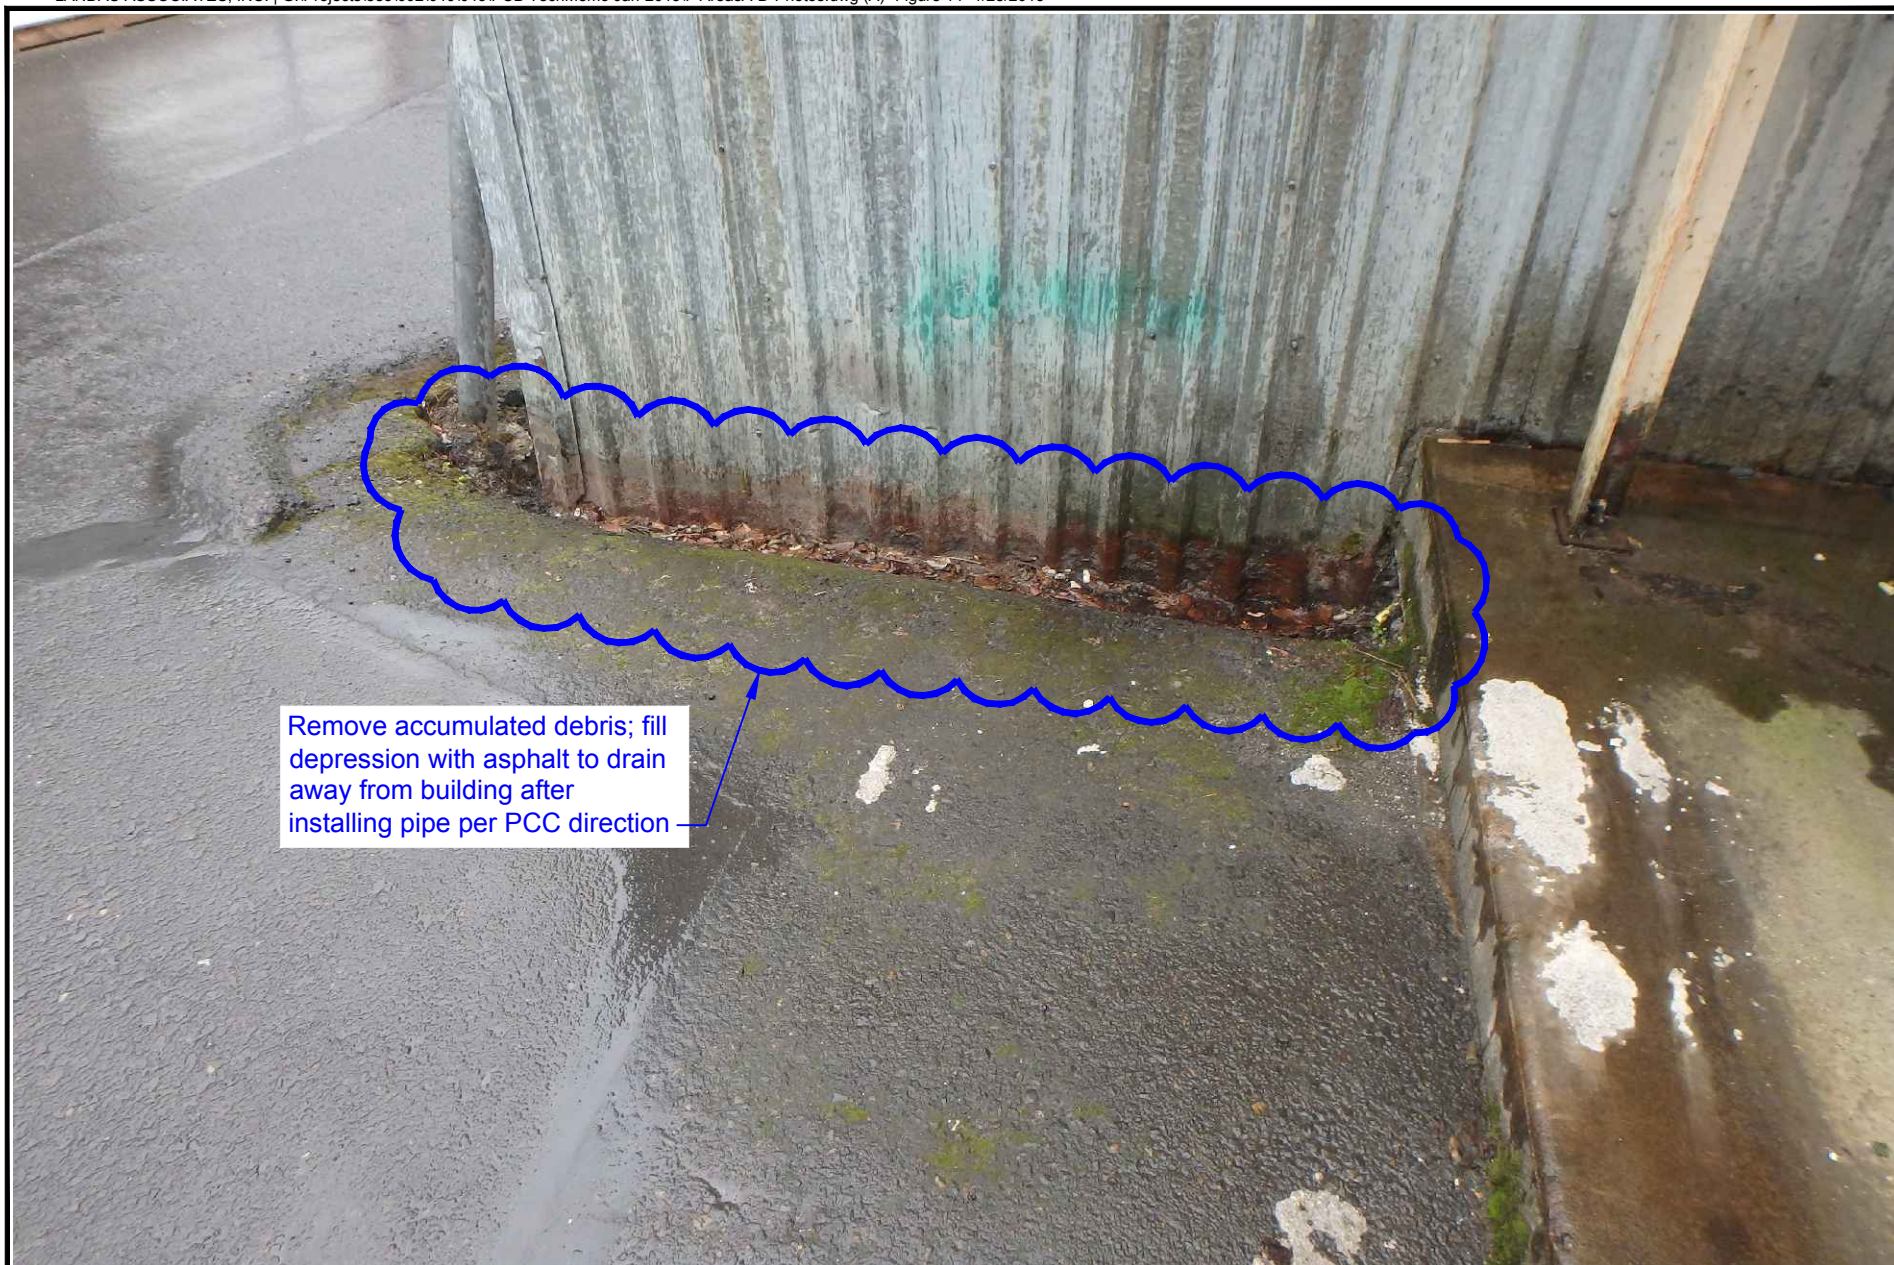
Remove accumulated debris; fill depression with asphalt to drain away from building after installing pipe per PCC direction

- Remove any re-accumulated debris (since the interim removal) and drum. Debris removal should be done in dry conditions via sweeping. Commercial sweepers may be used for easily accessible areas and hand brooms may be required for less accessible areas. Stored materials will be moved in order to ensure thorough cleaning.
- PCC intends to fill in depressions adjacent to the building with asphalt. This will be done such that the surface slopes away from the building, essentially eliminating the current areas of debris accumulation. Figure 12 shows Area C and the proposed actions, while Figures 13 through 15 are photographs of the building with the debris and depressions shown.
